ADJUSTING THE BUMPERS ON THE VERTICAL CRUNCH

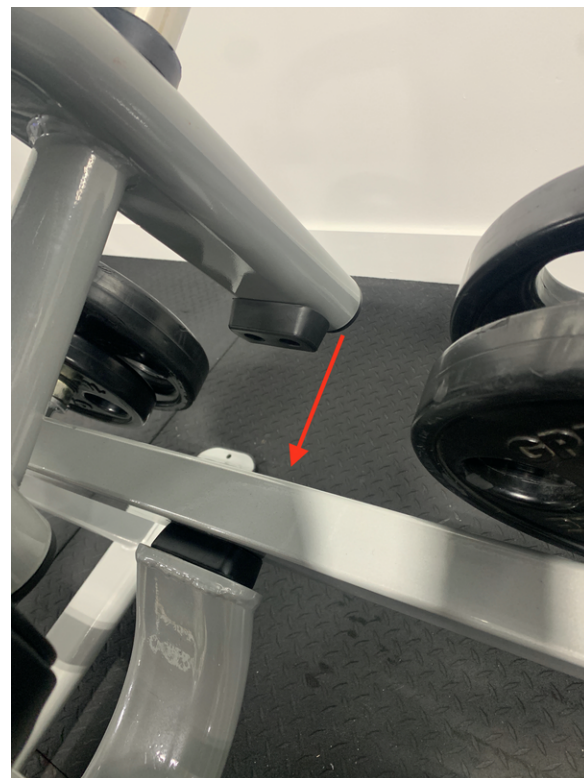
The most common issue related to the Vertical Crunch is miss-aligned bumpers as seen in the picture below. This situation will cause either the front or rear bumper to take the brunt of the return force and will contribute to it's accelerated demise. There should be no gap where the red arrow appears.

If the two bumpers do not meet together when the unit is at rest, then you will need to adjust it until they do.

Adjusting the space between the bumpers is done by adjusting the Transfer Bar that links the top and bottom actuators on the right side of the machine (if you are facing it) and can be done quickly with just an adjustable crescent wrench.
